Insulating Concrete Forms as a Blast Resistant Building Material

**Force Protection Equipment Demonstration
May 6, 7 & 8, 2003
Quantico Marine Corps Base**

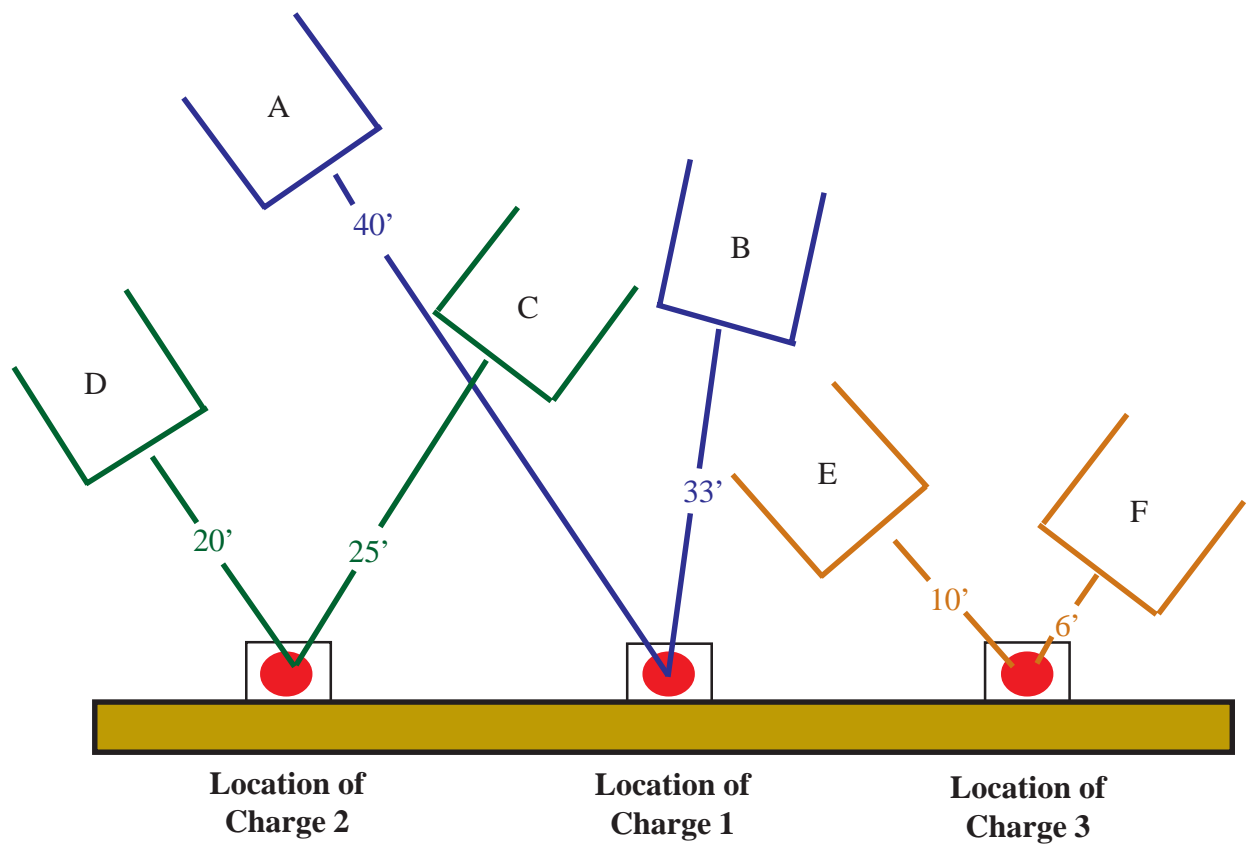
Figure 1 – Plan of the test. The standoff distance between the charge and the specimens ranged from 6’ to 40’. Each day, two specimens were tested after which they were analyzed and then removed.

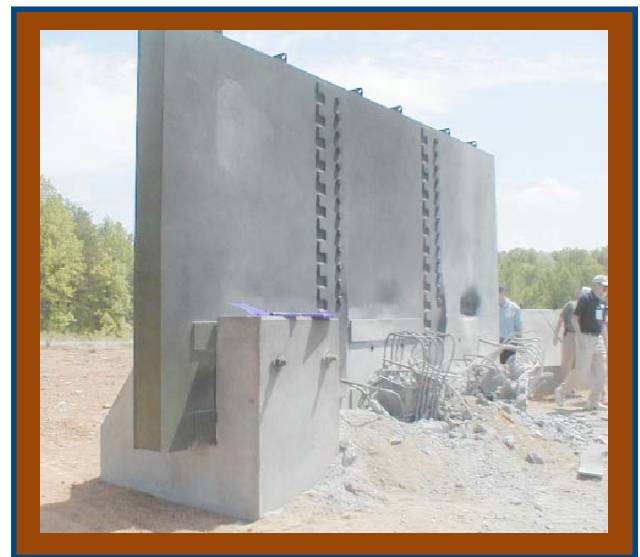
Image 3 - Location of explosive charges

Image 3 – Since the TNT charge decimated the concrete bolster on which it was sitting, the TNT charge was placed on a different bolster each day. This photograph was taken after the second day. The bolster to be used on the third day can be seen in the foreground. (The charge will be placed where the blue folder in the photograph is located.) The remnants of the bolsters used on the first and second day can be seen along the center and right side of the wall. The rebar in the bolsters is #7. Damage to the blast wall itself can also be observed behind the sites of the first and second charges.

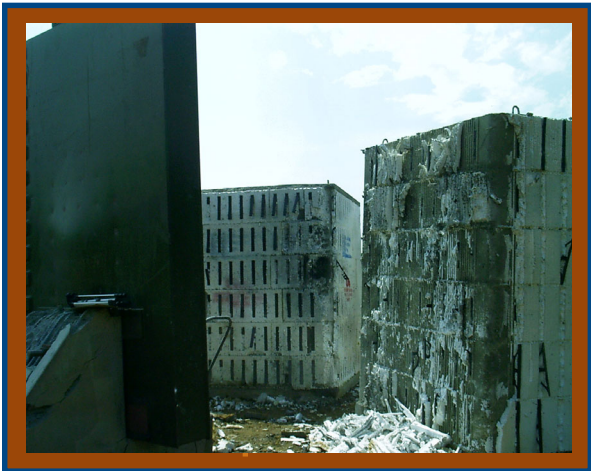
Image 4 - Blast area on May 8, 2003

Image 4 – Specimens E (left) and F (right). Signs of compression of the EPS can be seen in the wall facing the blast of Specimen E. (Note how the ribs are only seen on the side facing the blast.) Embedded shrapnel can be seen on the bottom of Specimen E. Also, although exposed, no damage was seen to the edge of the upper slab. Reaction Box F had the closest standoff distance to the charge. The EPS was severely damaged, but the concrete maintained its structural integrity.

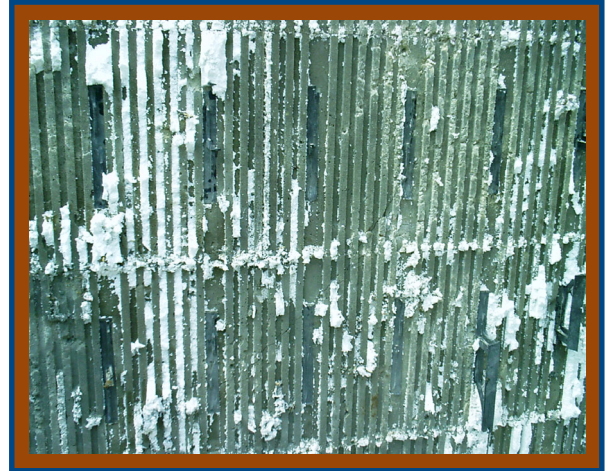
Image 5 - ICF wall at six feet

Image 5 - A close-up of the ICF wall at six feet stand-off distance.
